CASE REPORT

Strains of a virtuoso: pacemaker infection and ventricular tachycardia in a violinist

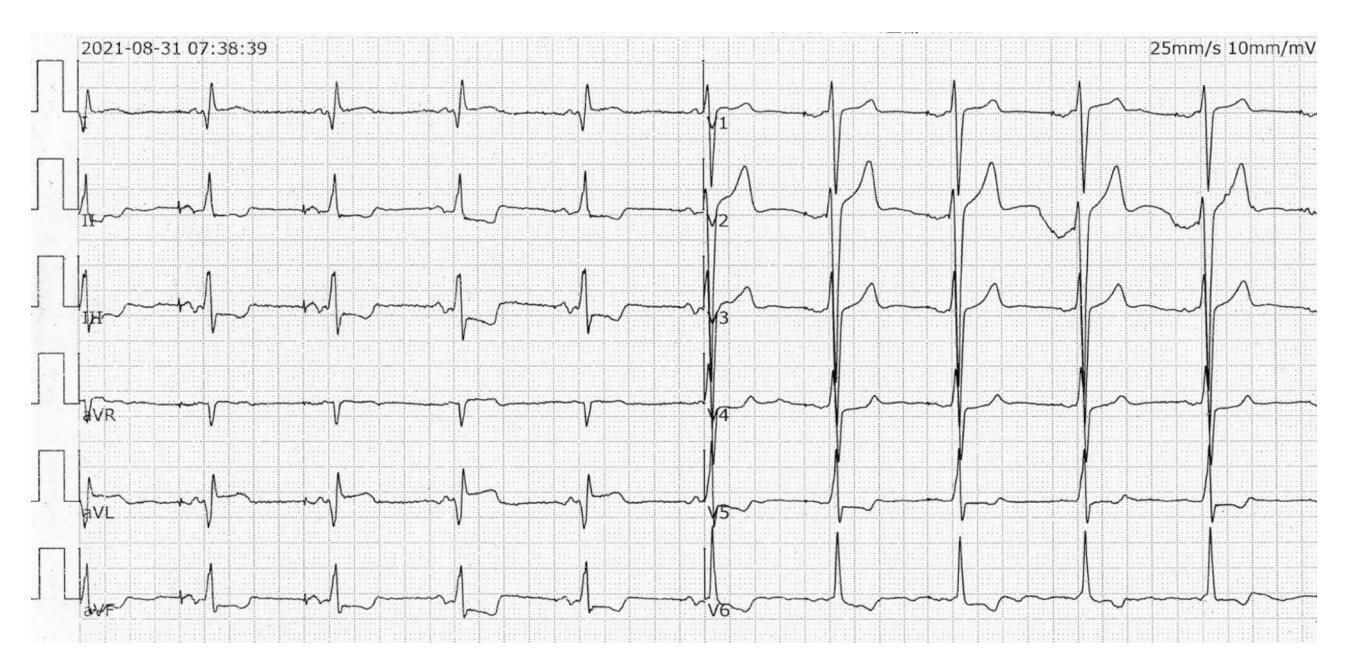
Fig. 1 The electrocardiogram (ECG) post-pacemaker implantation demonstrates VAT pacing mode with an atrial pacing rate of 60 beats per minute. The ECG indicates effective atrial sensing, atrial triggering, and ventricular sensing without ventricular pacing

A 76-year-old male Chinese amateur violinist with a history of sick sinus syndrome received an Evia DR (Pro MRI) dual-chamber pacemaker manufactured by Biotronik three years prior. Post-implantation, the electrocardiogram (ECG) showed AAI pacing mode (Fig. 1).

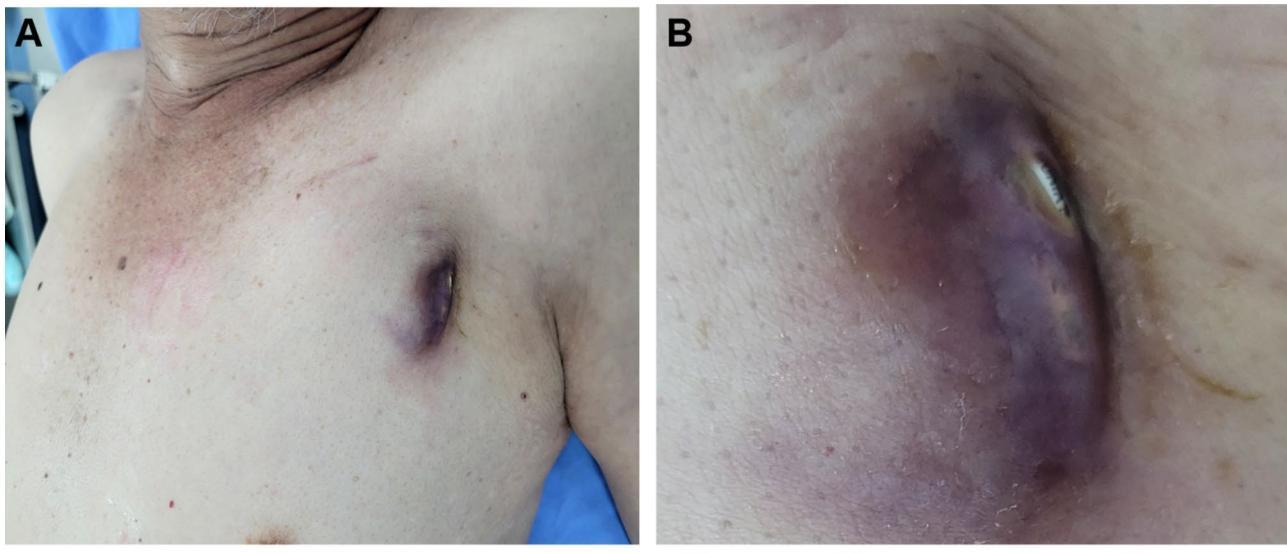
Overall view of the patient's chest

Close-up of the pacemaker pocket

Fig. 2 Panel A: An overall view of the patient's chest, showing the location of the pacemaker. Panel B: A close-up of the pacemaker pocket. The images reveal a pacemaker pocket infection with exposed leads and visible skin necrosis around the area, indicating a severe infection

Three years after implantation, the patient presented with syncope, localized redness, and pain due to pacemaker pocket infection and exposure under the left clavicle. Despite antibiotic treatment at a local hospital, the infection persisted (Fig. 2). Laboratory tests showed slightly elevated CRP but normal white blood cell count and other parameters. Blood cultures and pocket discharge cultures were negative. The patient presented with localized redness, pain, and syncope. ECG indicated recurrent VT (Figs. 3 and 4). Laboratory tests showed normal white blood cell count, liver and kidney function, electrolytes, and coagulation profiles. CRP was slightly elevated. Initial diagnosis was pacemaker pocket infection. Echocardiography (Fig. 5) and chest X-ray (Fig. 6) confirmed that the ventricular lead was positioned at the free wall of the right ventricular outflow tract, where the VT originated.

The patient's profession as a violinist involves repetitive use of the left shoulder, which likely contributed to mechanical wear and erosion at the pacemaker site, increasing the risk of infection. However, the absence of detectable pathogens in the cultures suggests that the inflammatory response could be partially due to noninfectious factors such as mechanical irritation, although the clinical presentation and response to antibiotics indicate an infectious process.

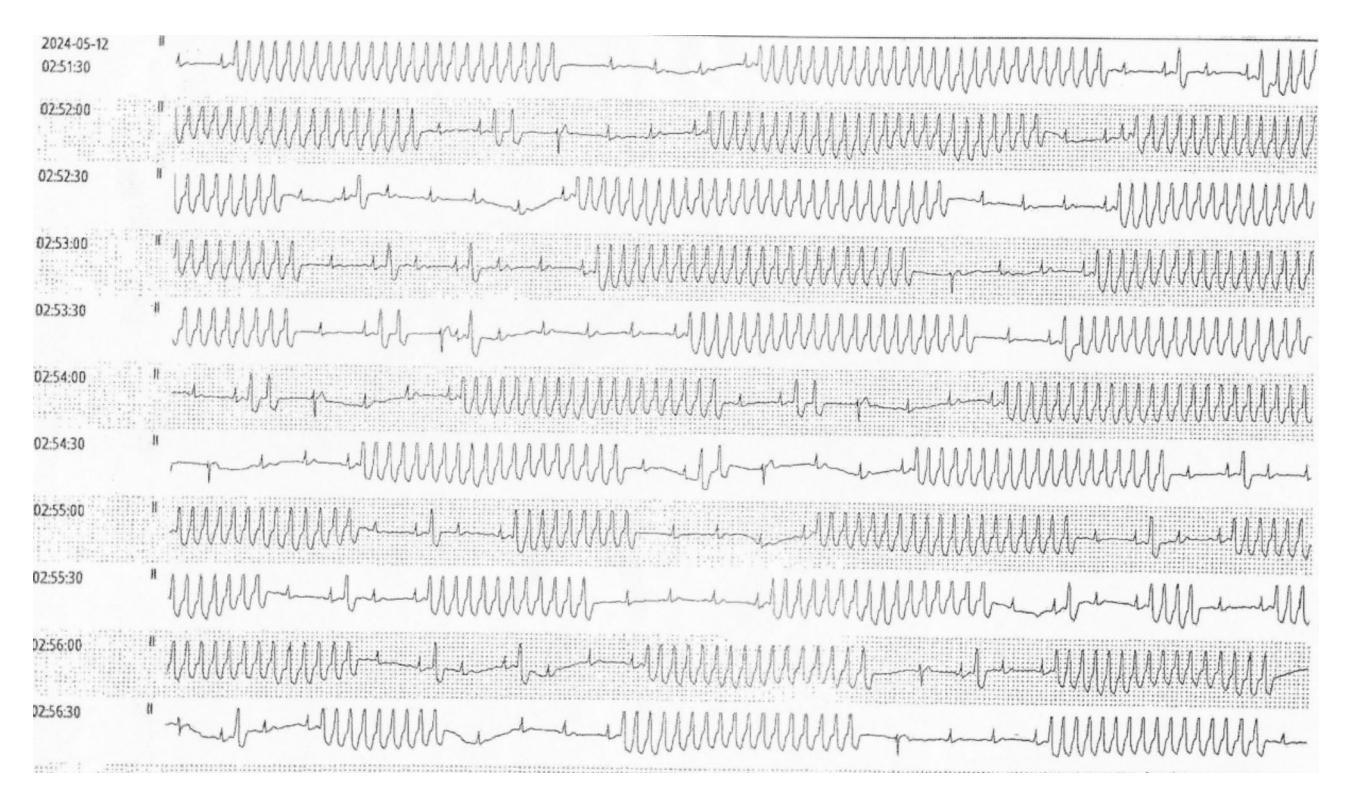
Fig. 3 Recurrent ventricular tachycardia during the CCU hospitalization following pacemaker infection. The ECG tracings, recorded in standard lead II, highlight multiple episodes of ventricular tachycardia, indicating the severity of the arrhythmia associated with the pacemaker infection

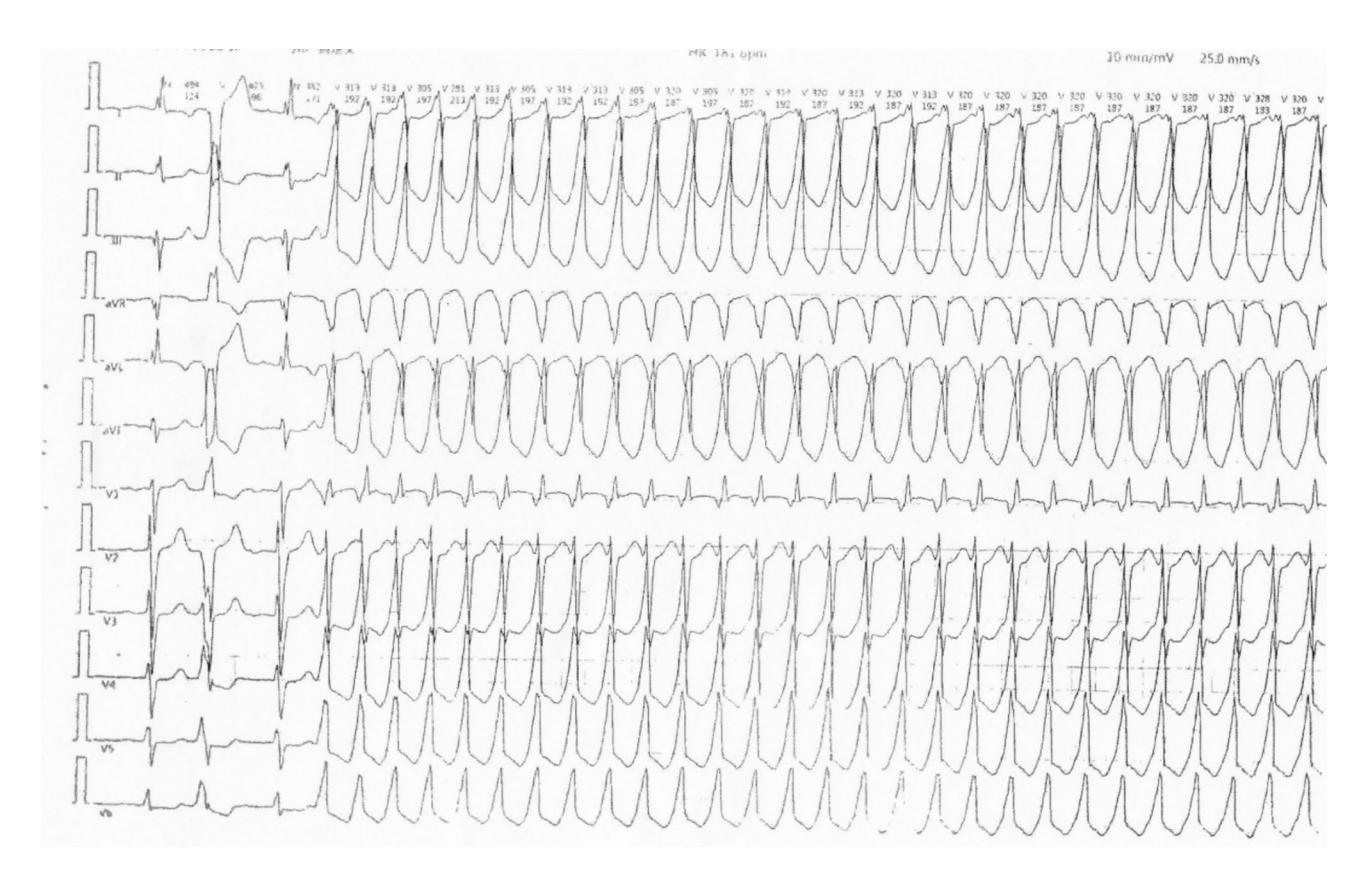
Fig. 4 Standard 12-lead electrocardiogram (ECG) recording of a ventricular tachycardia (VT) episode in the patient. The VT has a rate of approximately 190 beats per minute. In lead I, the QRS complex displays an R-wave pattern. Leads II, III, and aVF show predominantly positive QRS complexes with the main deflection being upward. The precordial leads (V1-V6) indicate an early transition, characterized by the shift of the QRS complex to a predominantly positive direction earlier than expected, suggesting the VT may originate from a location other than the typical right ventricular outflow tract (RVOT)

free wall. The variability in QRS morphology, with lead I showing Rs pattern to rS pattern, leads II, III, aVF showing R pattern, lead V1 showing R pattern, and lead V2 showing rS pattern, may be due to local electrode movement or regional cardiac conduction variations. The termination of VT upon removal of the RVOT free wall

electrode further supports this origin despite the atypical ECG presentation [5].

The gradual changes in QRS morphology observed during ventricular tachycardia (VT) in this patient with a right ventricular outflow tract (RVOT) pacemaker lead suggest variable contact between the lead tip and myocardial cells. Despite these morphological changes, the VT frequency remains constant, indicating a stable pacing source likely at the lead tip. These observations are independent of body position changes, reinforcing that the QRS variations are due to local contact variations rather than positional changes of the heart. This phenomenon underscores the significant impact of lead tip positioning on QRS waveform characteristics [7–9].

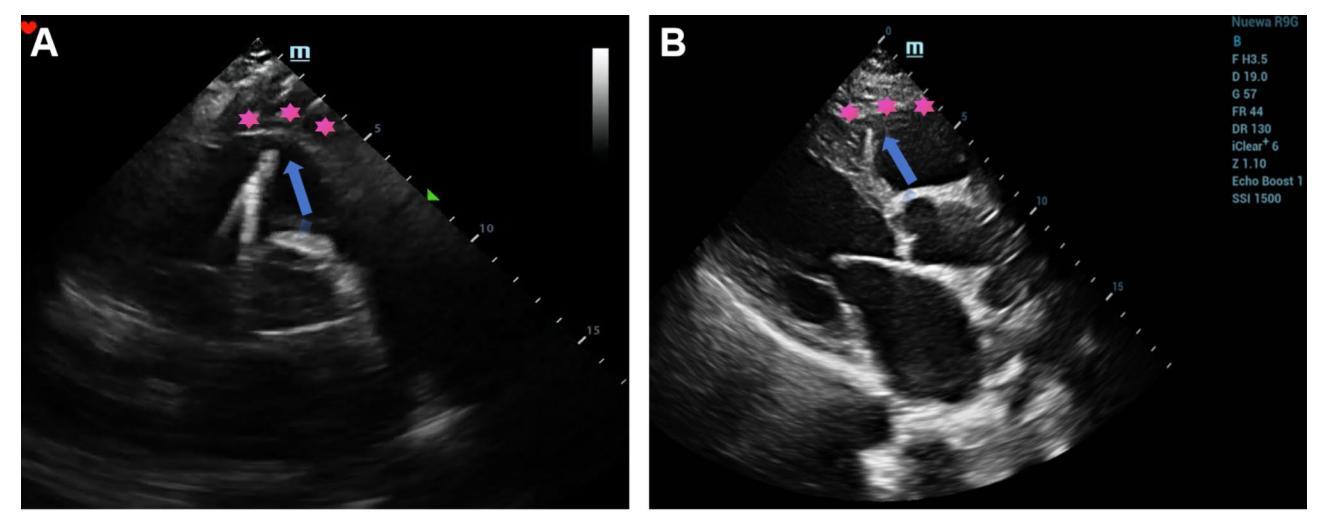
Parasternal Long-Axis View of the Left Ventricle (PLAX)

Fig. 5 Panel A: Parasternal short-axis view of the great arteries. Panel B: Parasternal long-axis view of the left ventricle. In both images, the blue arrows indicate the ventricular lead, while the star symbol marks the free wall of the right ventricle. The images demonstrate that the right ventricular lead is positioned at the free wall of the right ventricle, which is identified as the origin of the ventricular tachycardia

The unique presentation of VT in this case was associated with the pacemaker lead's positioning in the right ventricular outflow tract, suggesting that the inflammation around the lead, whether infectious or mechanically induced, could exacerbate arrhythmogenicity [2–4]. Although the patient's ventricular tachycardia (VT) ECG characteristics are not typical, they still suggest a likely origin from the right ventricular outflow tract (RVOT)

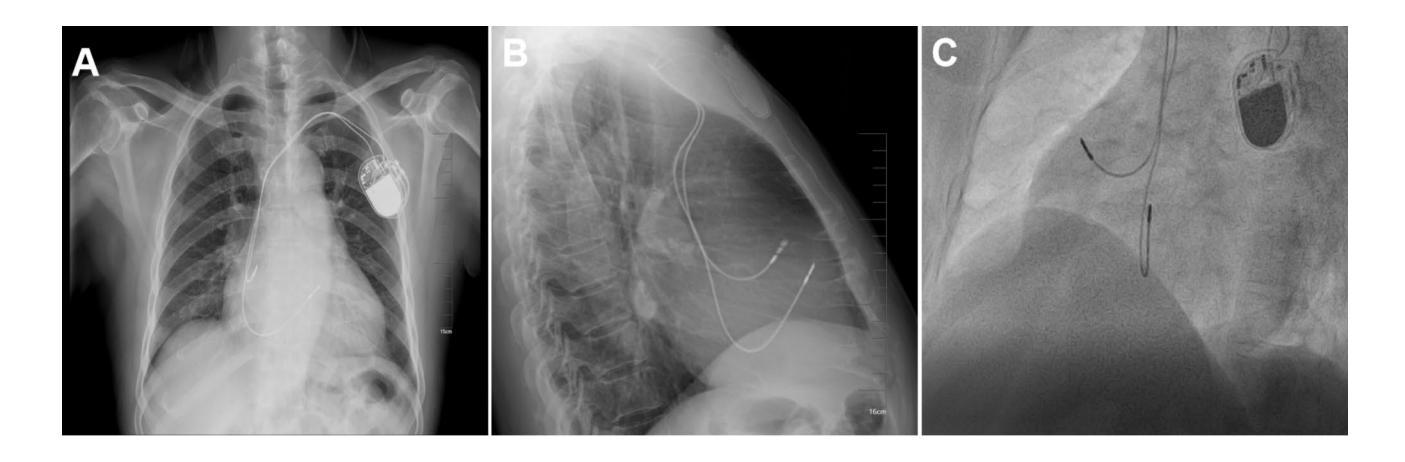
AP chest radiograph

Lateral chest radiograph

Left lateral view at 45°

Fig. 6 This figure is divided into three panels, illustrating the positioning of the pacemaker leads. Panel A: Anteroposterior (AP) chest radiograph. This image shows the overall position of the pacemaker leads within the chest. Panel B: Lateral chest radiograph. This side view provides additional detail on the spatial orientation of the leads. Panel C: Left anterior oblique (LAO) view at 45 degrees under digital subtraction angiography (DSA). This fluoroscopic image highlights the specific locations of the pacemaker leads. The images collectively indicate that the right atrial lead is positioned in the right atrial appendage, while the right ventricular lead is situated in the right ventricular outflow tract, leaning towards the free wall rather than the interventricular septum. These details are critical for understanding the lead placement and potential implications for cardiac function and arrhythmia management

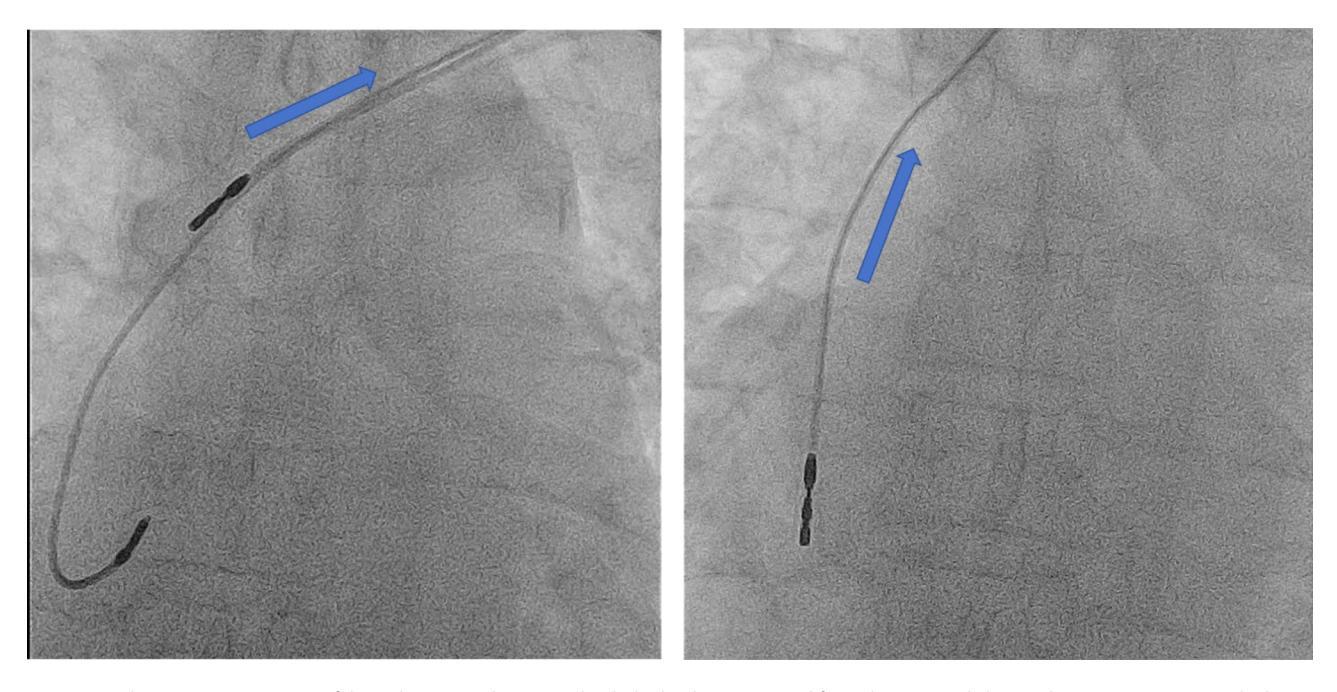
Fig. 7 Panel A: Extraction process of the right ventricular pacing lead. The lead is unscrewed from the myocardial tissue by rotating it counterclockwise and then gently pulled out of the body. Panel B: Extraction process of the right atrial pacing lead. After the right ventricular lead has been removed, the right atrial lead is similarly rotated counterclockwise to disengage it from the atrial myocardial tissue and then carefully pulled out of the body. The blue arrows in both panels indicate the direction in which the leads are being pulled out of the body

Debridement and percutaneous extraction of the pacemaker and leads were performed. The extraction process involved counterclockwise rotation to detach the leads from myocardial tissue (Fig. 7). During the procedure, VT occurred but was managed successfully. Post-procedure, the patient received broad-spectrum antibiotics.

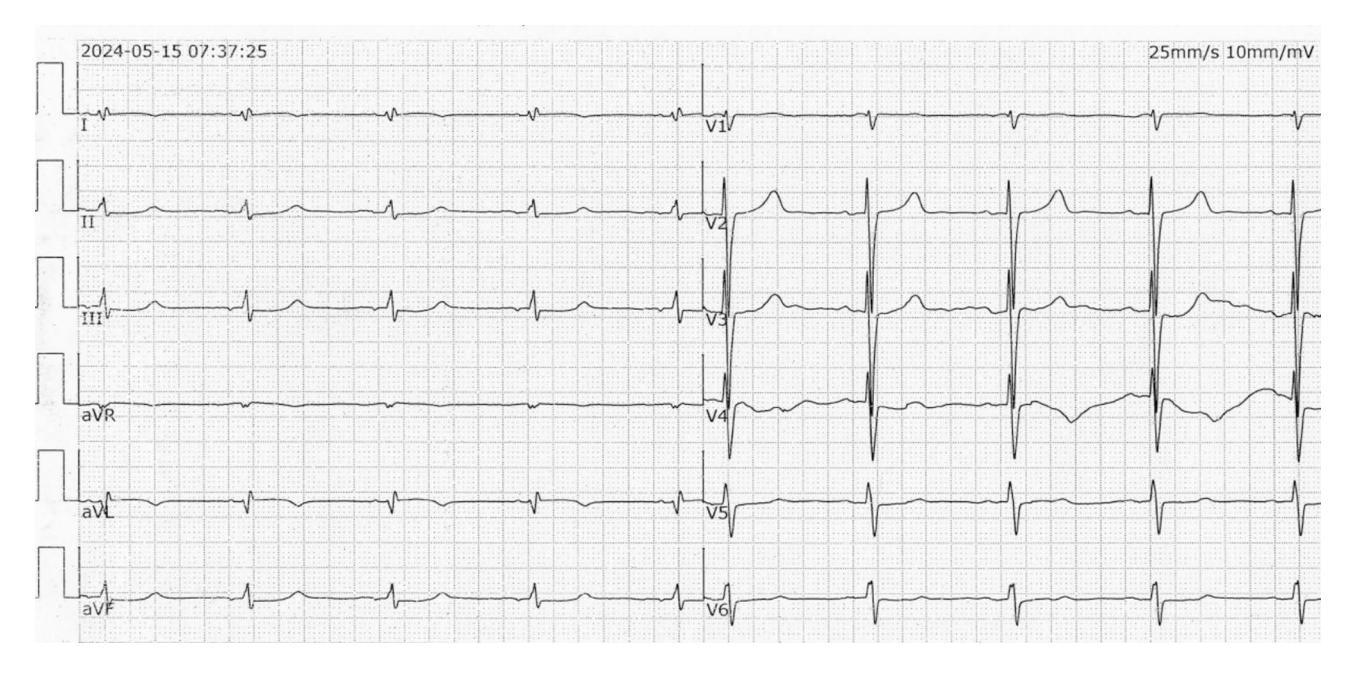
Fig. 8 ECG following the removal of the pacemaker leads. The ECG displays a sinus rhythm with a heart rate of 52 beats per minute. There are no episodes of ventricular tachycardia or ventricular premature contractions observed

The patient's VT resolved, and no further syncope episodes occurred. Postoperative ECG indicated sinus rhythm with a ventricular rate of 50–60 bpm (Fig. 8). The patient was discharged on postoperative day 7 with no recurrence of infection or arrhythmia at follow-up.
